Attachment 2

Attachment 3
Photograph Log

Photograph Log for EPA's December 3, 2010 Electrochem Solutions RCRA and CWA Inspection

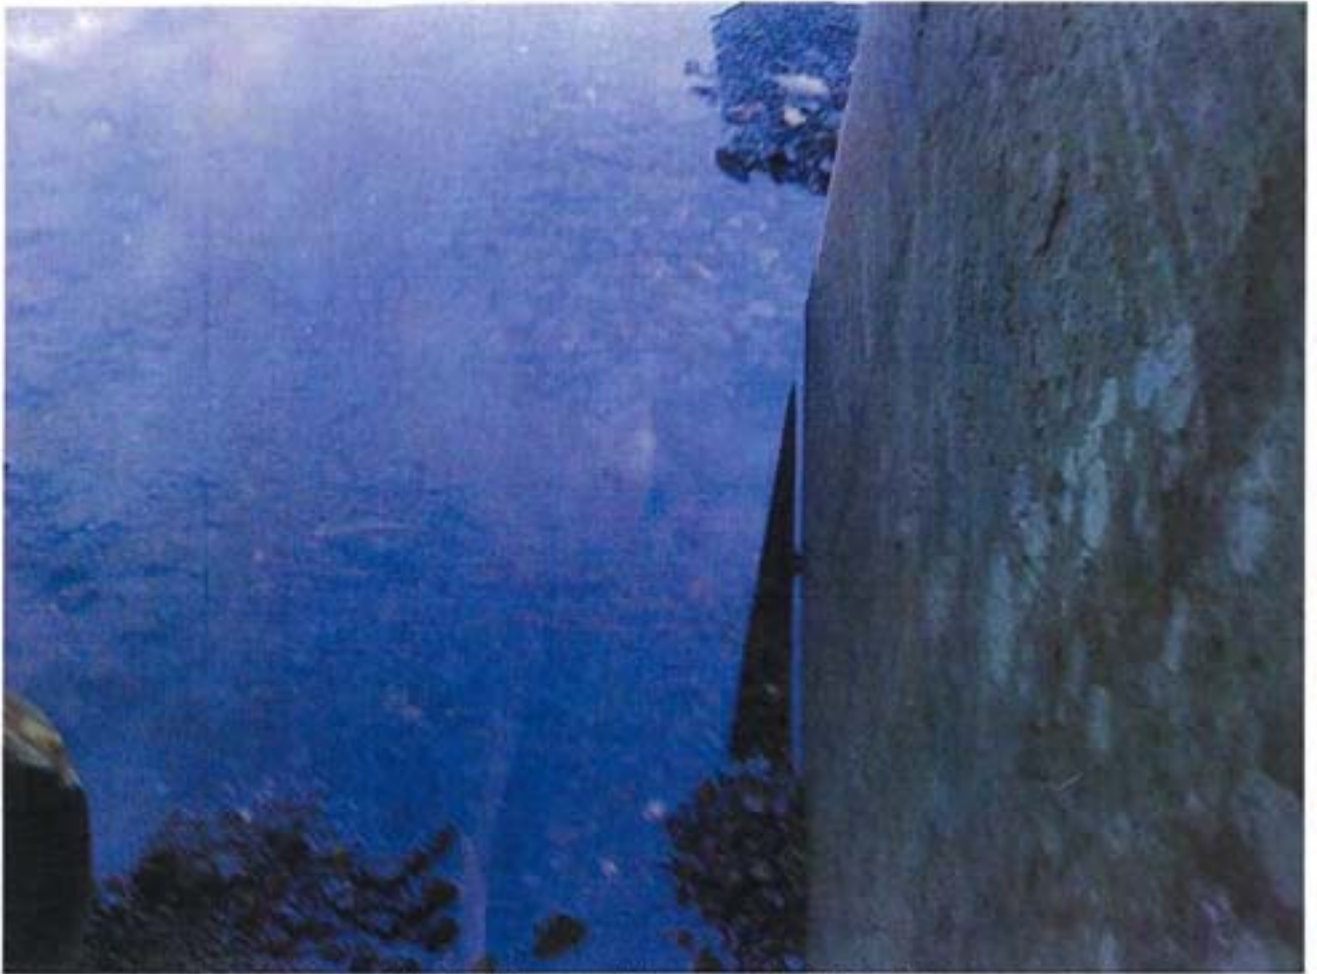
Electrochem cut storm drain 12-9-10

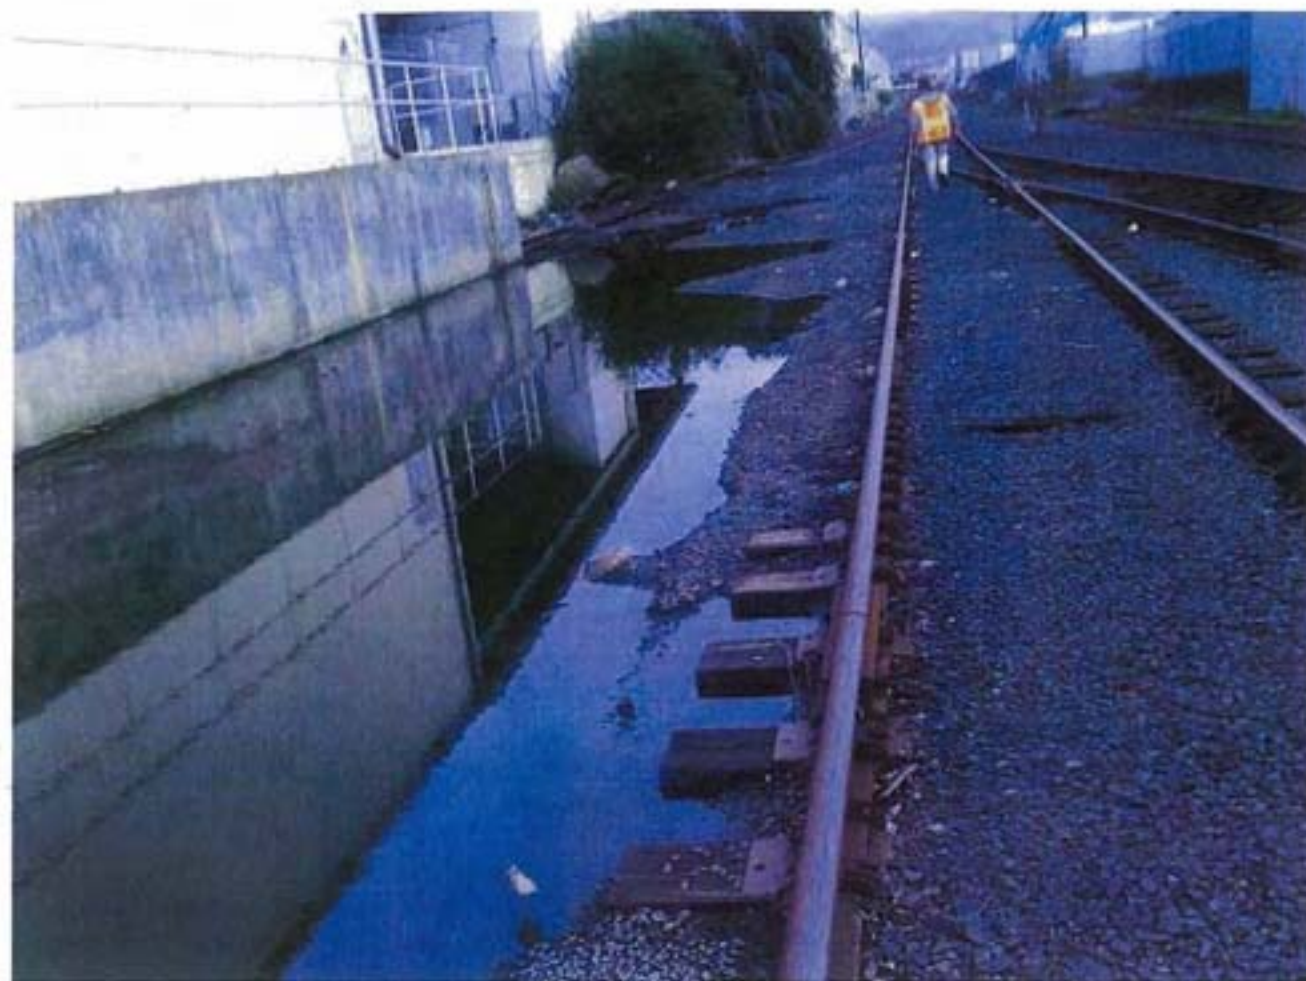
Storm water ponding rail spur 12-9-10

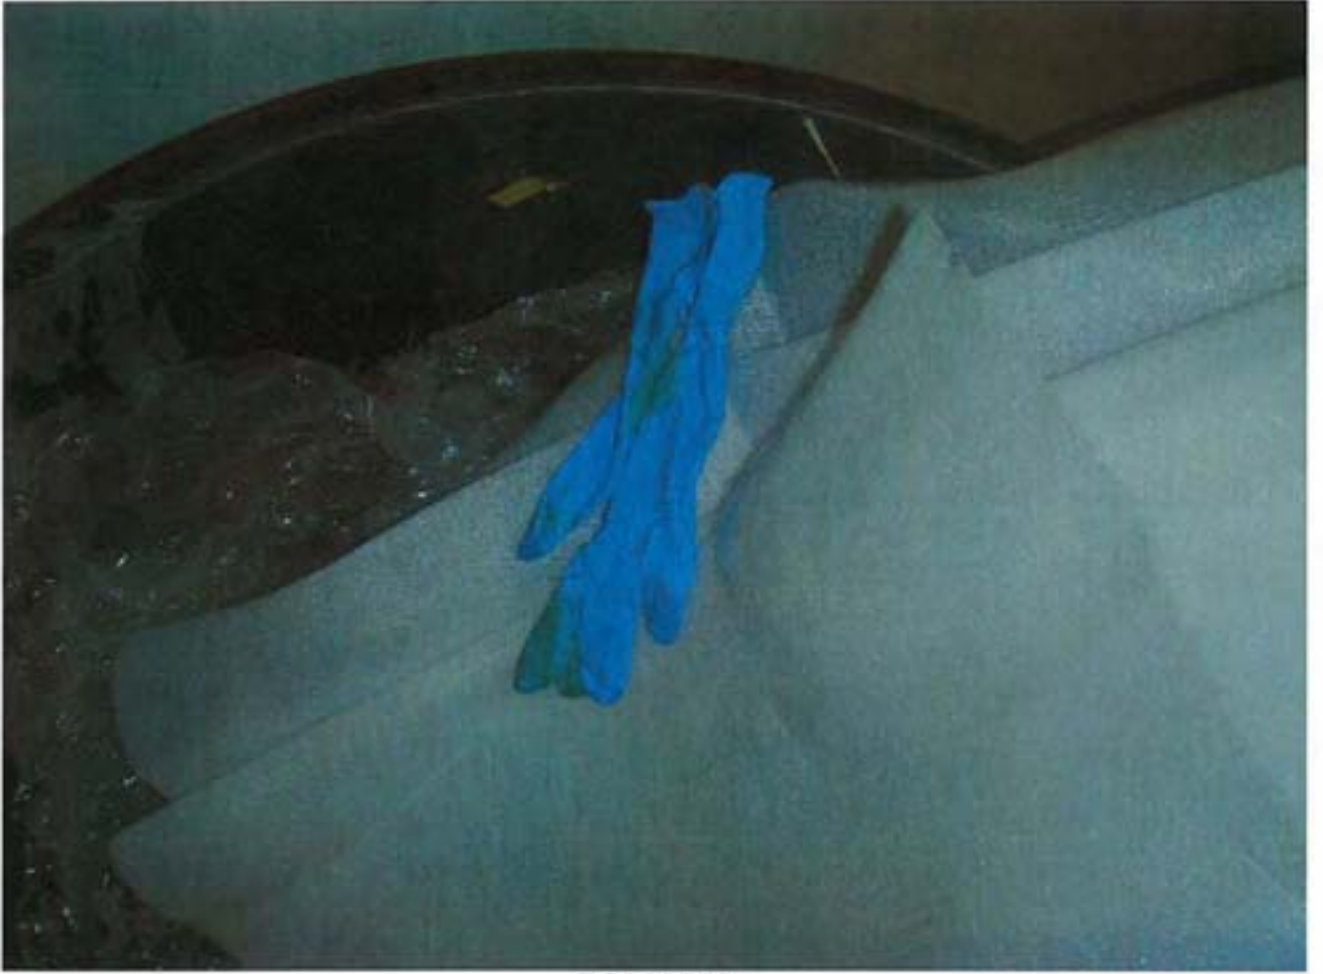
PC030003

- 003. Production Room: Solid waste trash container. Contaminated gloves and wipes observed within the trash container. Note: staining on glove.
- 004. Main Wet Processing Area: Two unlabeled 55-gallon containers of used gold strip (cyanide).

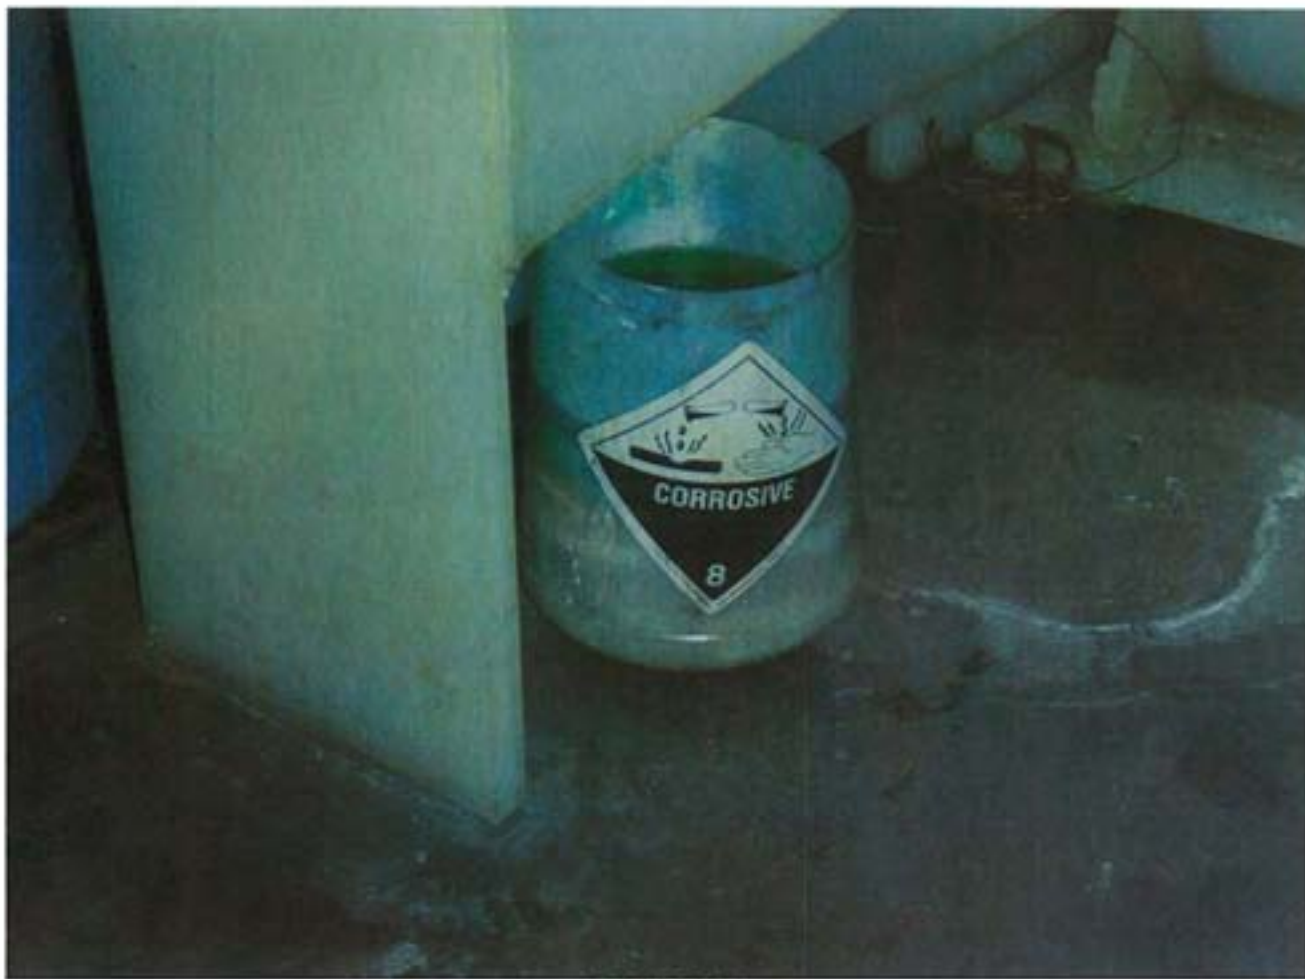
PC030006

- 006. Main Wet Processing Area: Unknown liquid in an open container under a table adjacent to the six 55-gallon containers in previous photograph.
- 007. Main Wet Processing Area: An open and un-secured container of gold strip (cyanide) product.

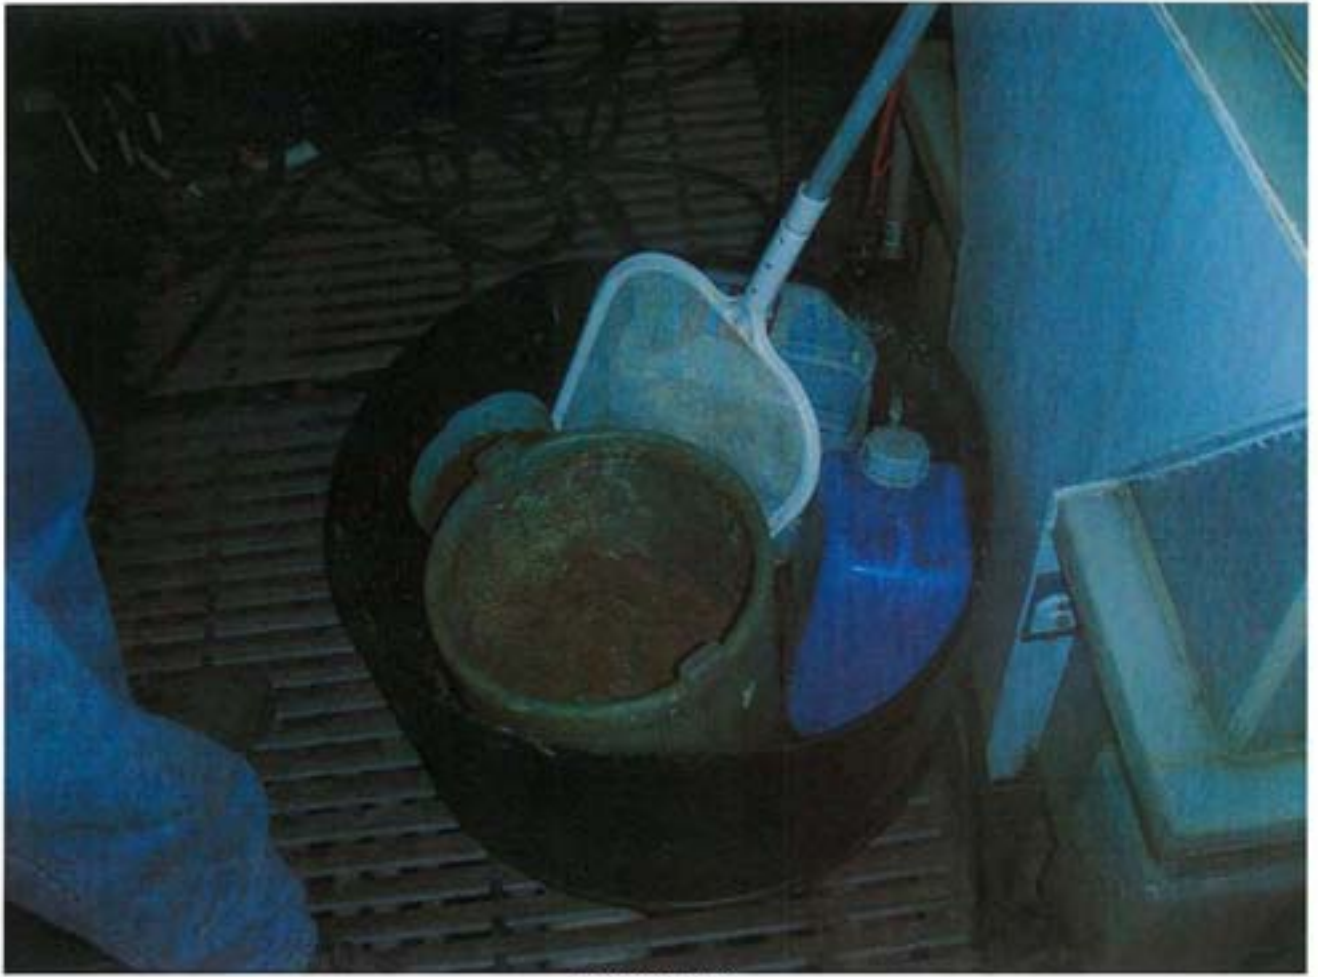
PC030008

- 008. Main Wet Processing Area: Open and unlabeled container of silver tarnish solution waste.
- 009. Main Wet Processing Area: A 55-gallon container of tin waste. Note: the label is smudged and difficult to read.

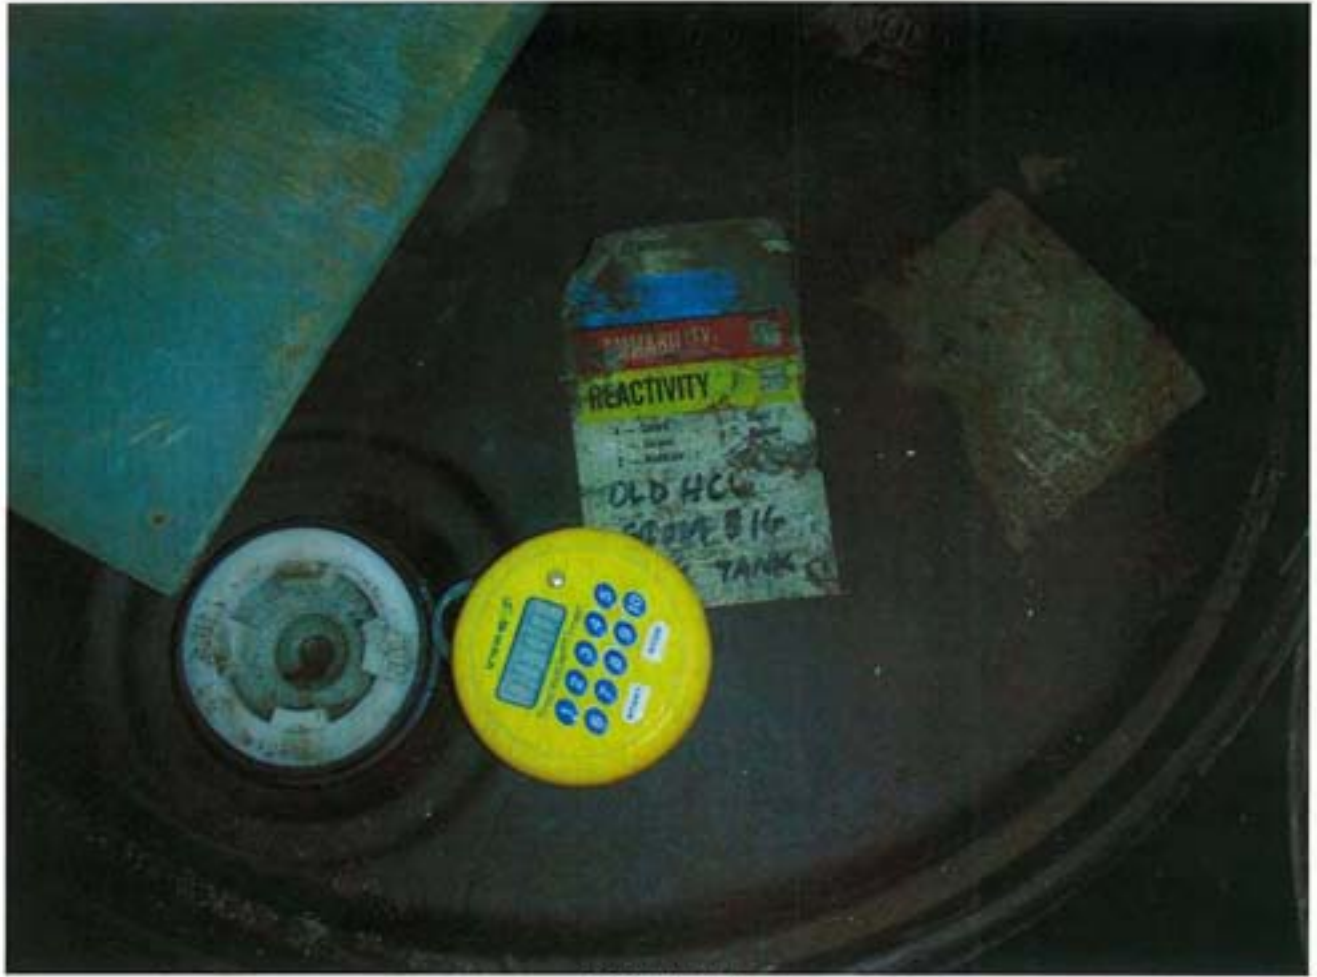
PC030015

014. Anodizing Area: Overview shot of eleven 55-gallon containers of nickel, sulfamate, and hydrochloric acid waste.
015. Anodizing Area: Close up of the label for the hydrochloric acid 55-gallon container. Note: no accumulation start date or other required labeling information.

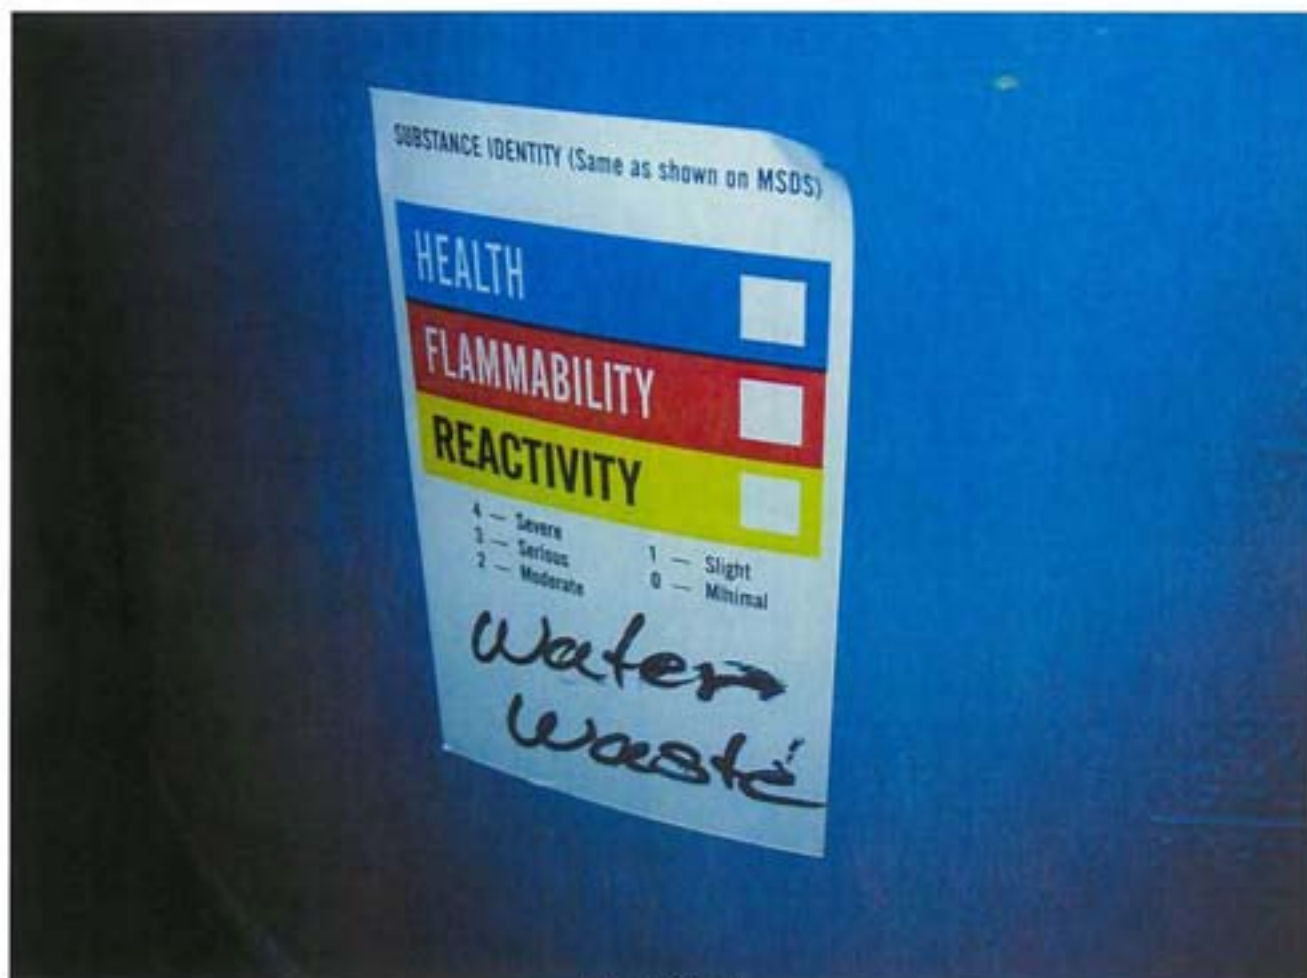
PC030017

017. Anodizing Area: Close up of the label on the 55-gallon container in the previous photograph.
018. Anodizing Area: Inside of trash can containing contaminated gloves.

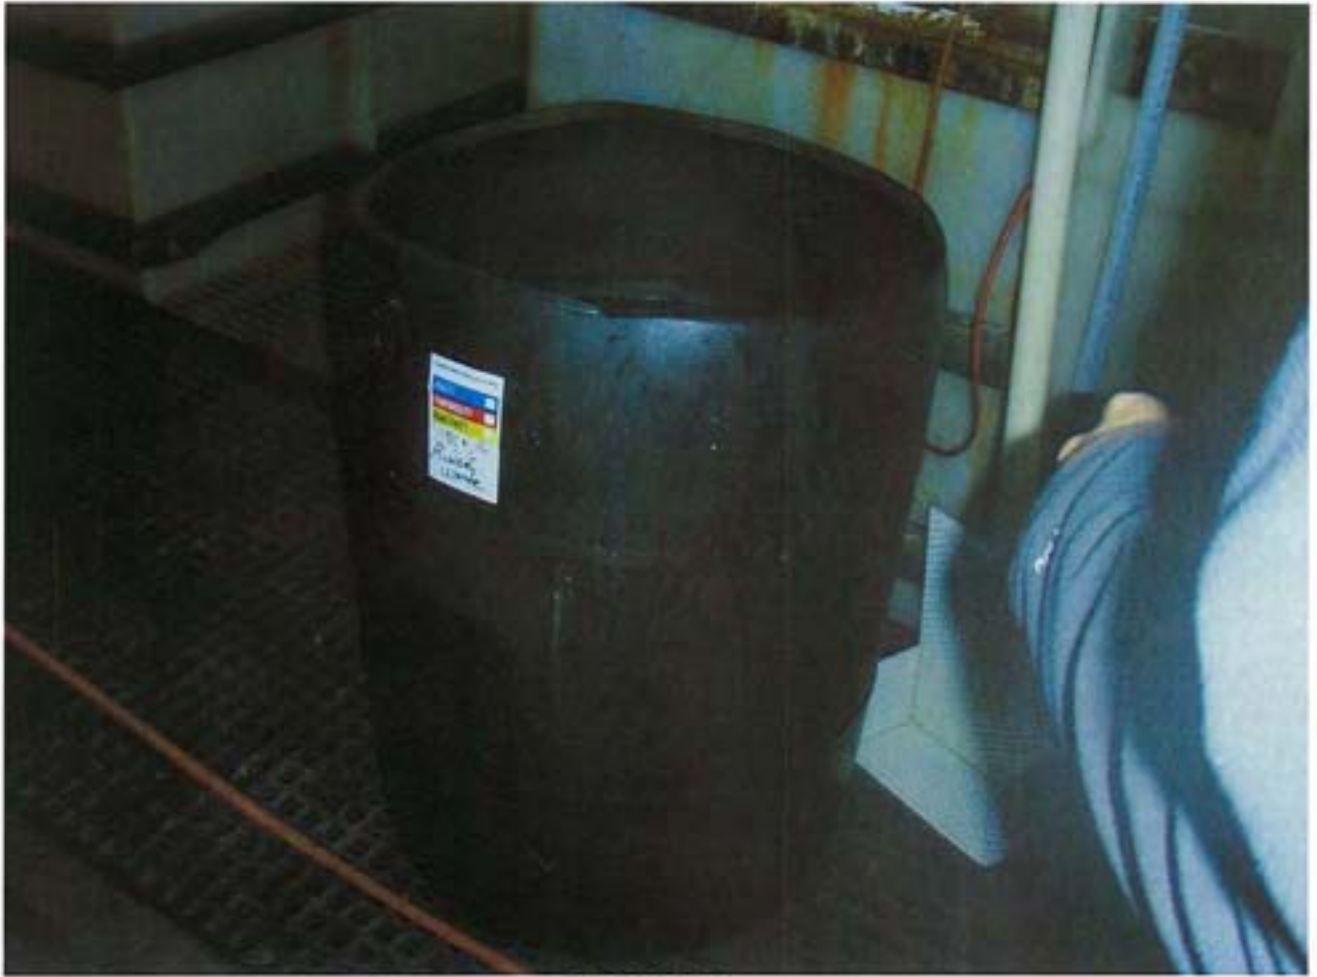
PC030020

019. Anodizing Area: Open and unlabeled cut 55-gallon container. Facility representative stated that it contained dichromate waste water.
020. Anodizing Area: Open cut top 55-gallon container labeled "rinse water." Facility representative stated that it contained nitric acid and 40% nickel strip wastewater.

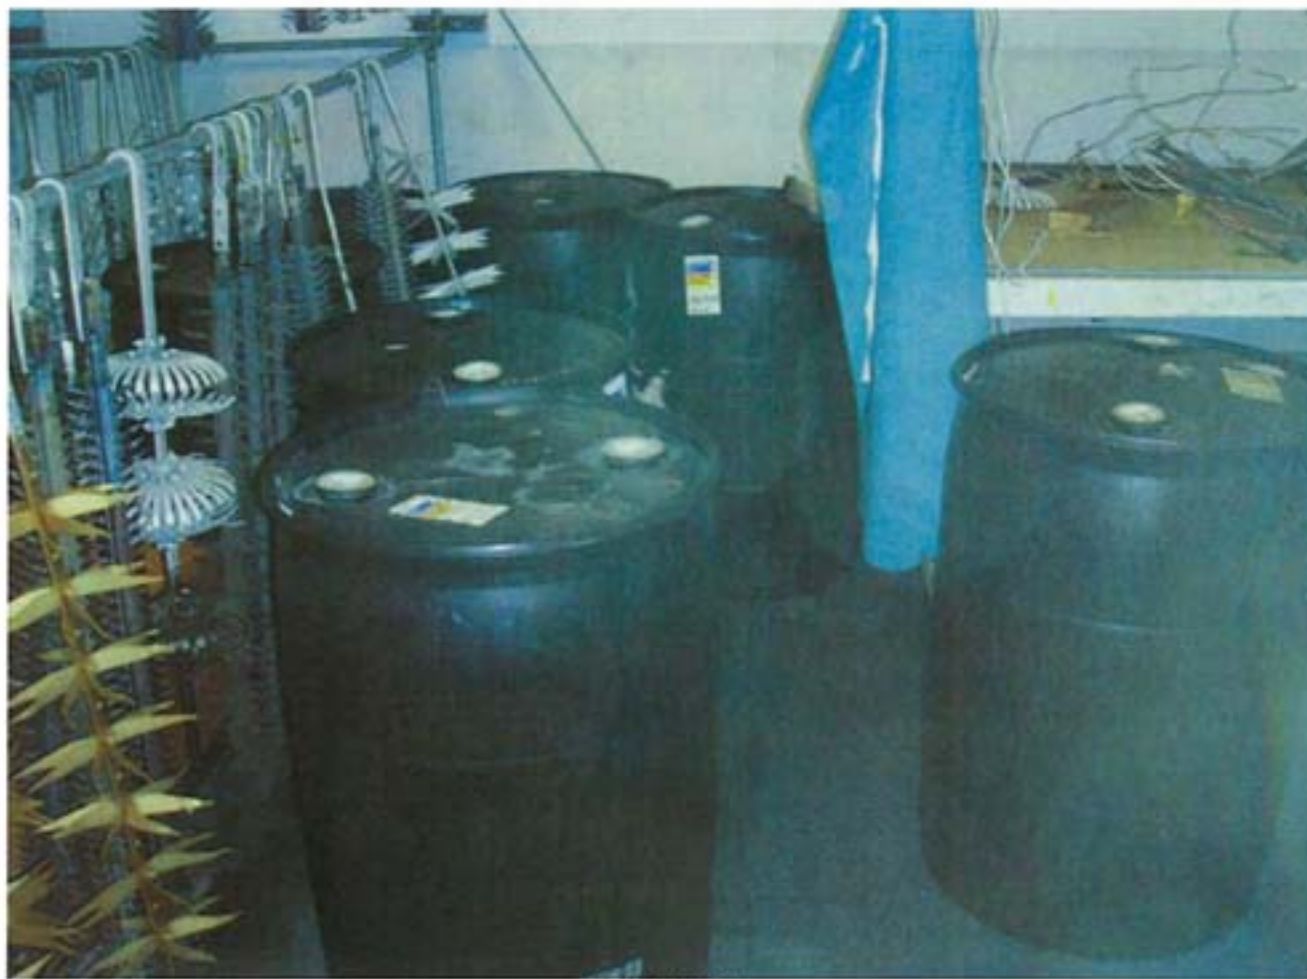
PC030021

021. Anodizing Area: Seven 55-gallon containers. There is one product container, one nitric acid waste container, and five nickel waste containers. None of the waste containers had accumulation start dates or other required labeling information.

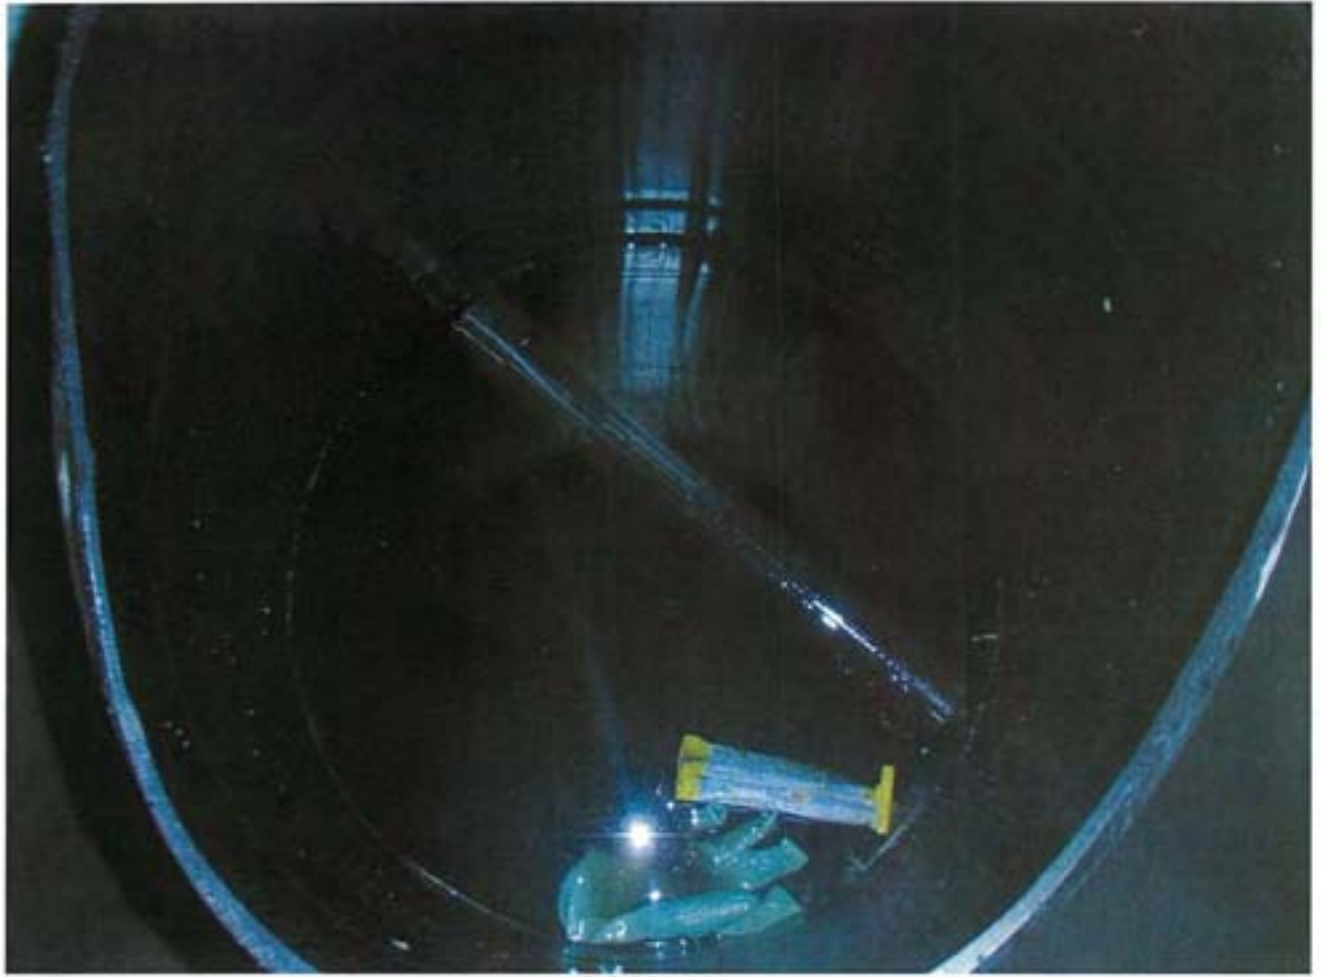
PC030023

022. Anodizing Area: An open 5-gallon container of unknown substance.
023. Anodizing Area: Open cut top 55-gallon container labeled "waste water." Facility representative stated it was placed in the location to collect rain water from a leak in the roof.

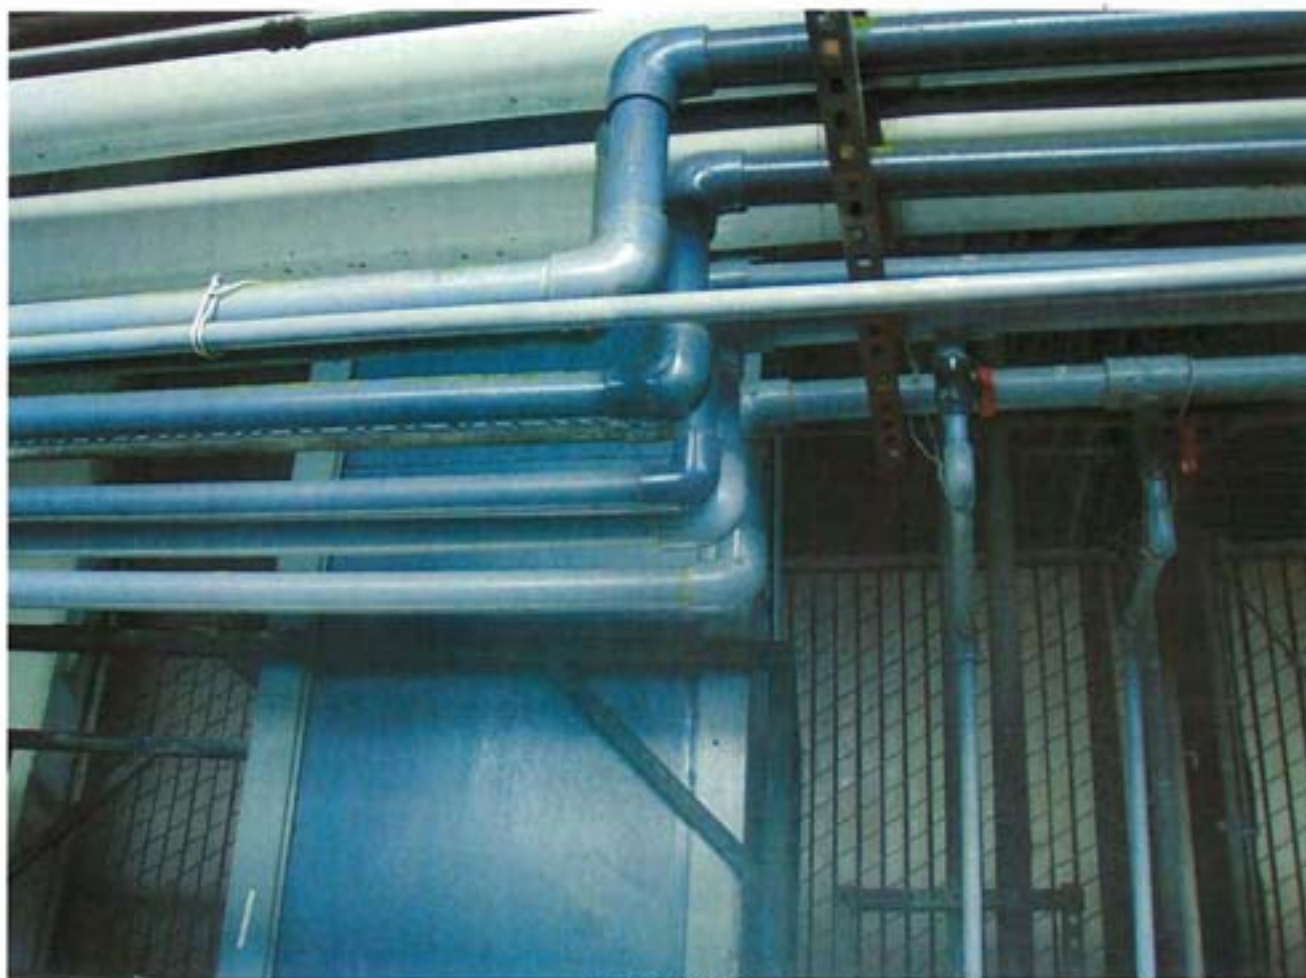
PC030025

024. Utility Room: Nine 55-gallon containers of glycol product. Note: the bungs on two of the containers were open.
025. Utility Room: Leaking pipes.
026. Utility Room: Concrete under leaking pipes in previous photograph is corroded.

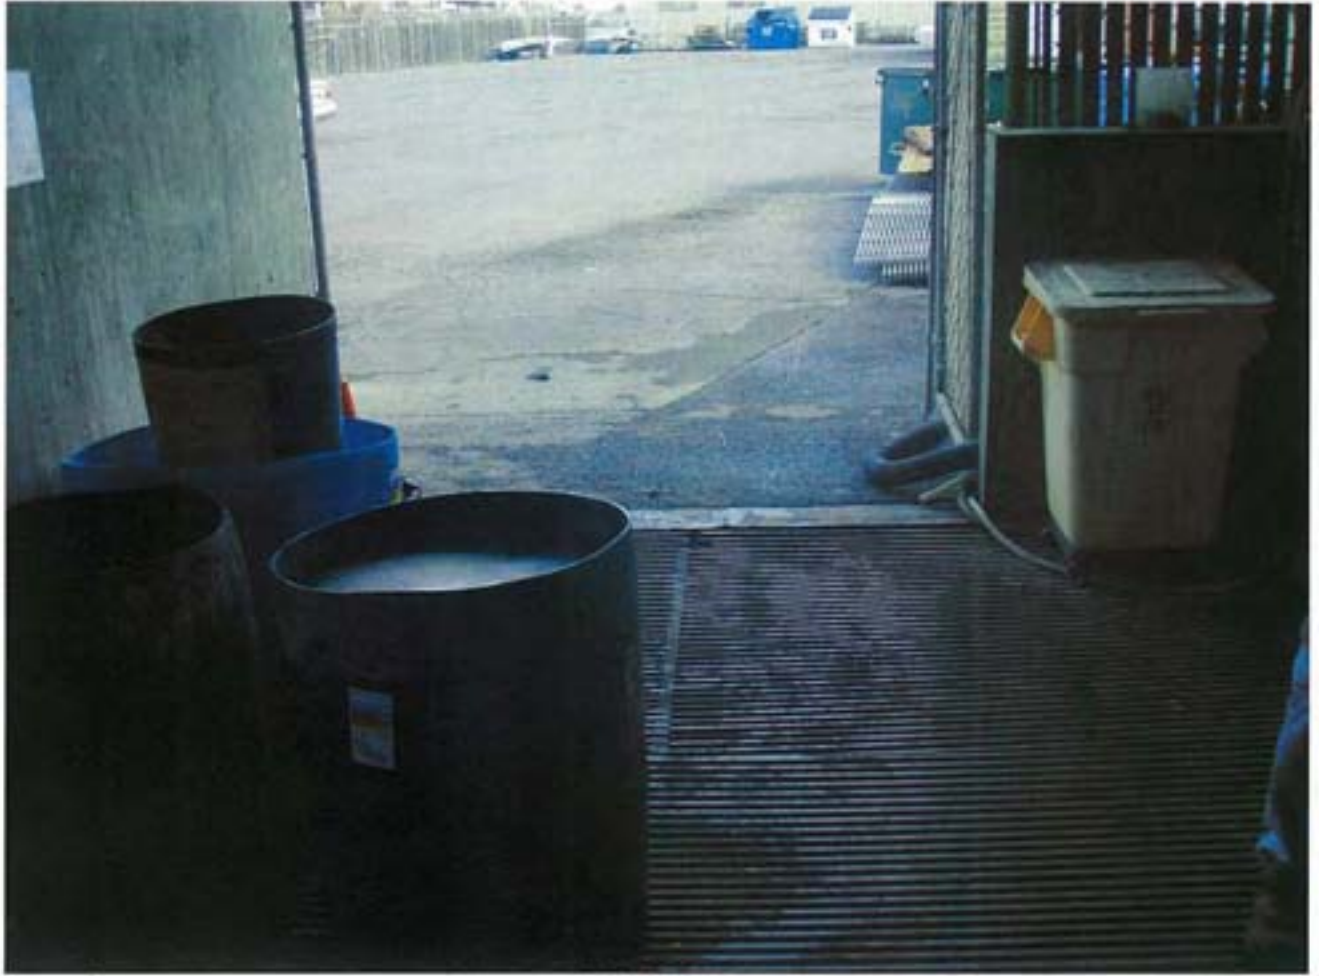
PC030029

- 029. Water Treatment and Equipment Area: Overview of the area facing towards outdoor area. Note: three open and cut top 55-gallon containers in close proximity to the door, bypassing the sump.

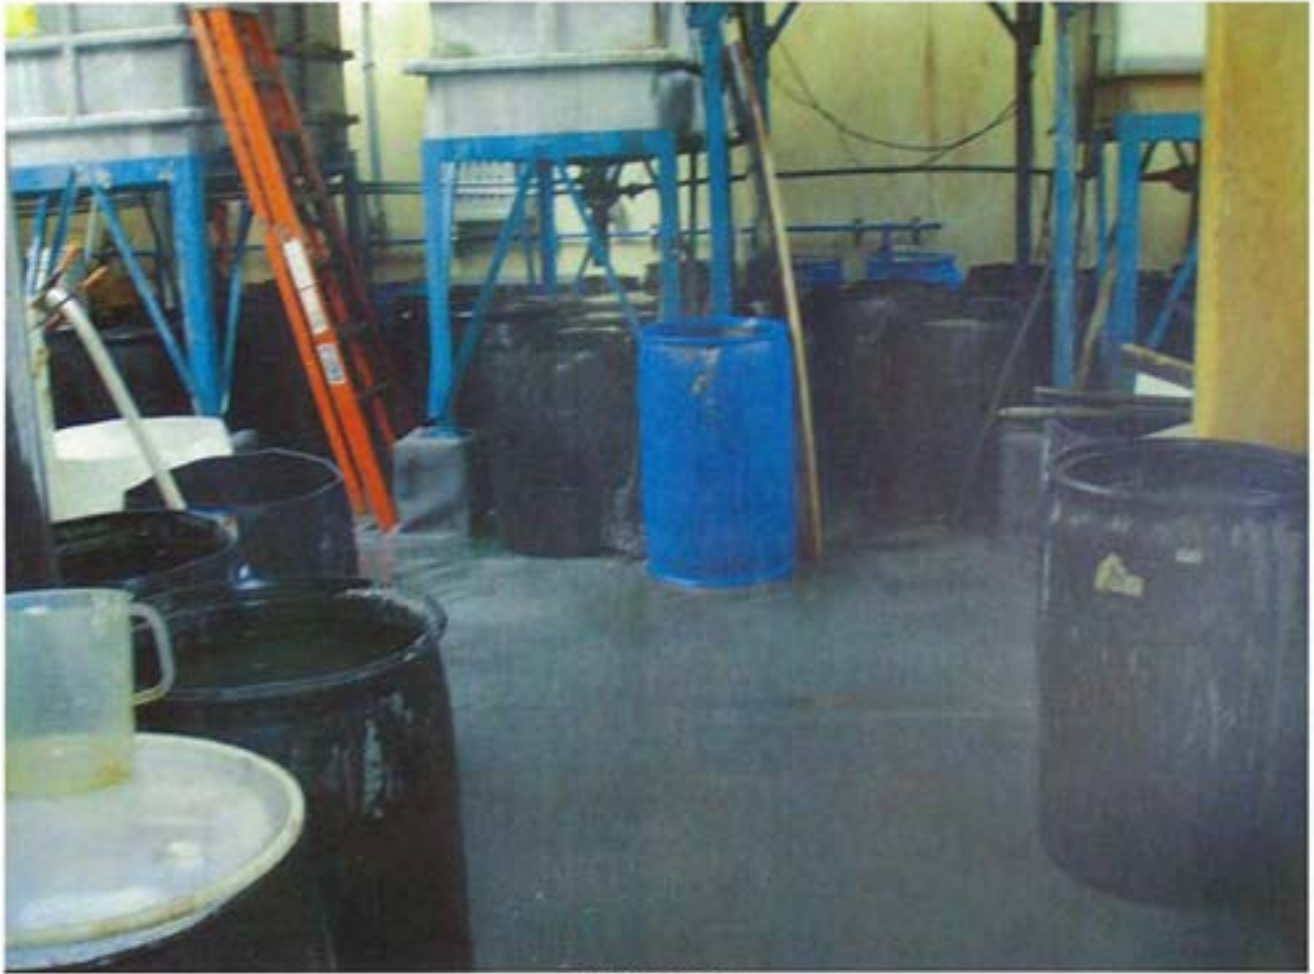
PC030034

- 034. Bulk Waste Processing Area: View of the area from the entryway from the Water Treatment and Equipment Area. Note: numerous containers are open and unlabeled.

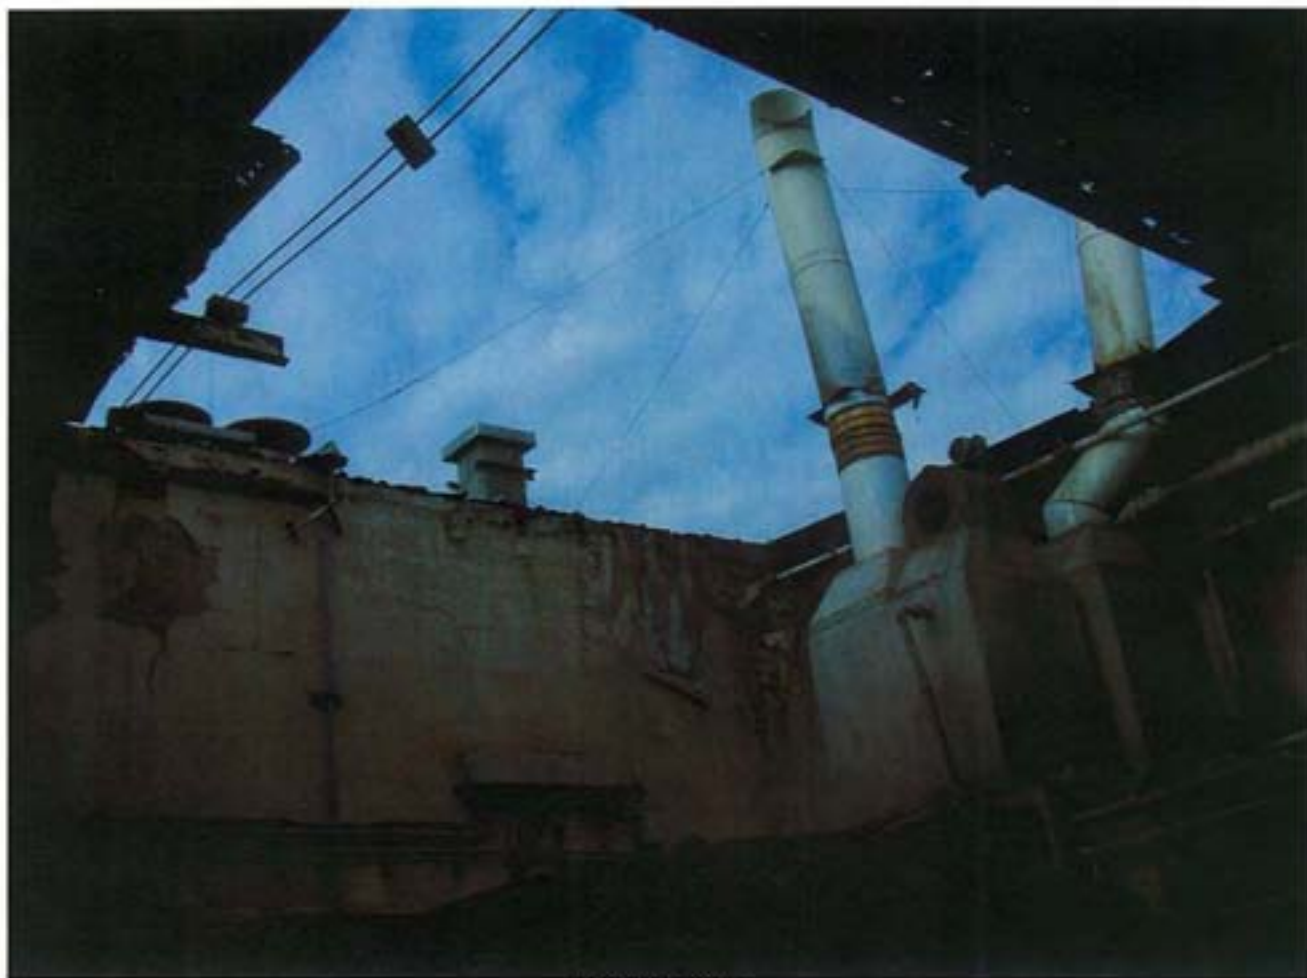
PC030035

- 035. Bulk Waste Processing Area: The roof corroded off this portion of the building.
- 036. Bulk Waste Processing Area: Six open top 55-gallon containers and one long rectangular container. One of the containers is labeled "sludge."

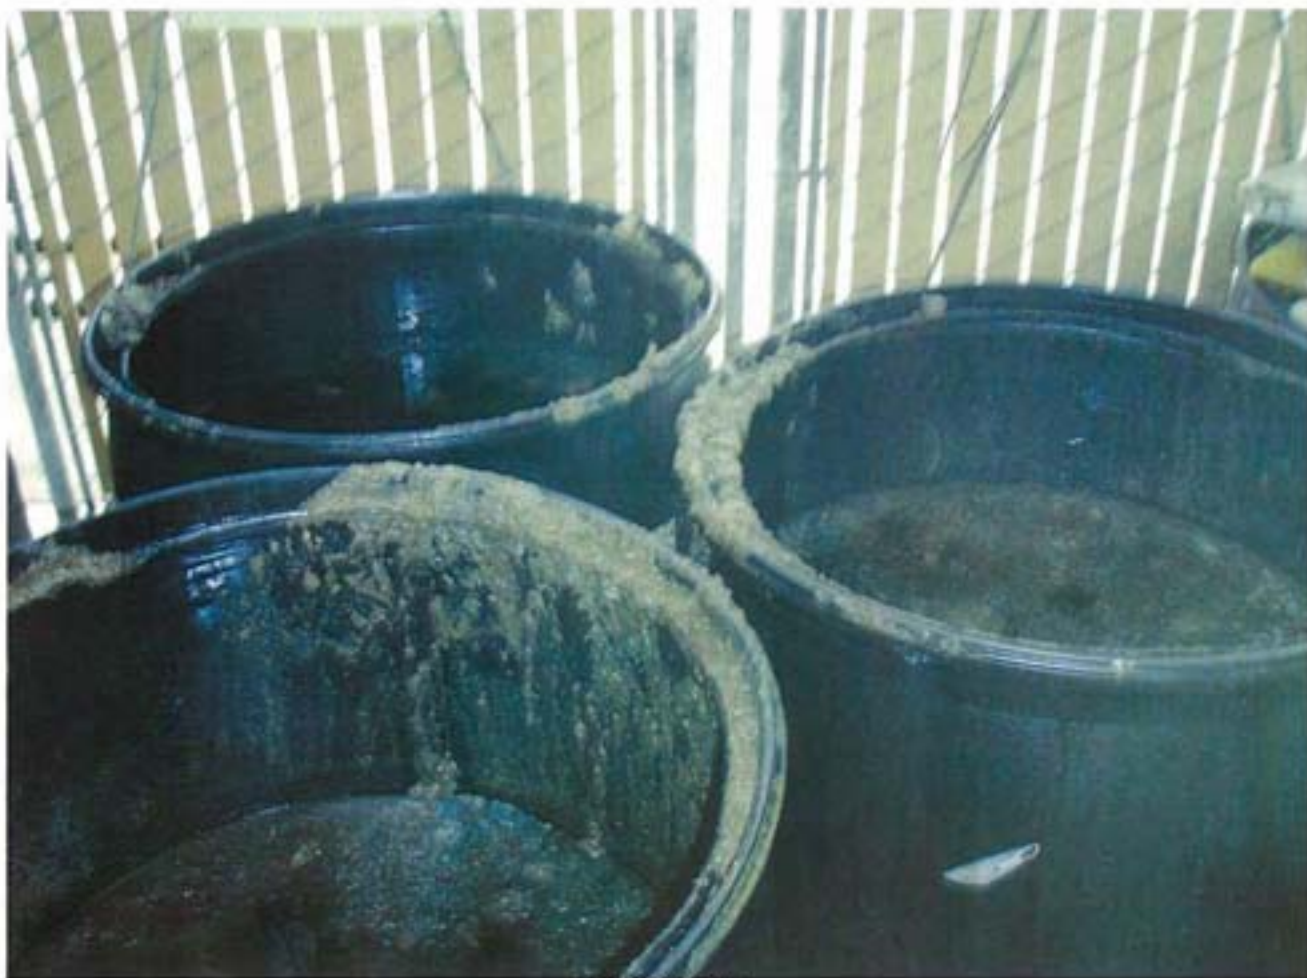
PC030039

- 039. Bulk Waste Processing Area: Three open top 55-gallon containers placed near the fence, bypassing the sump and perimeter wall.
- 040. Bulk Waste Processing Area: Ten open top 55-gallon containers and one 5-gallon open container and one 5-gallon closed container.

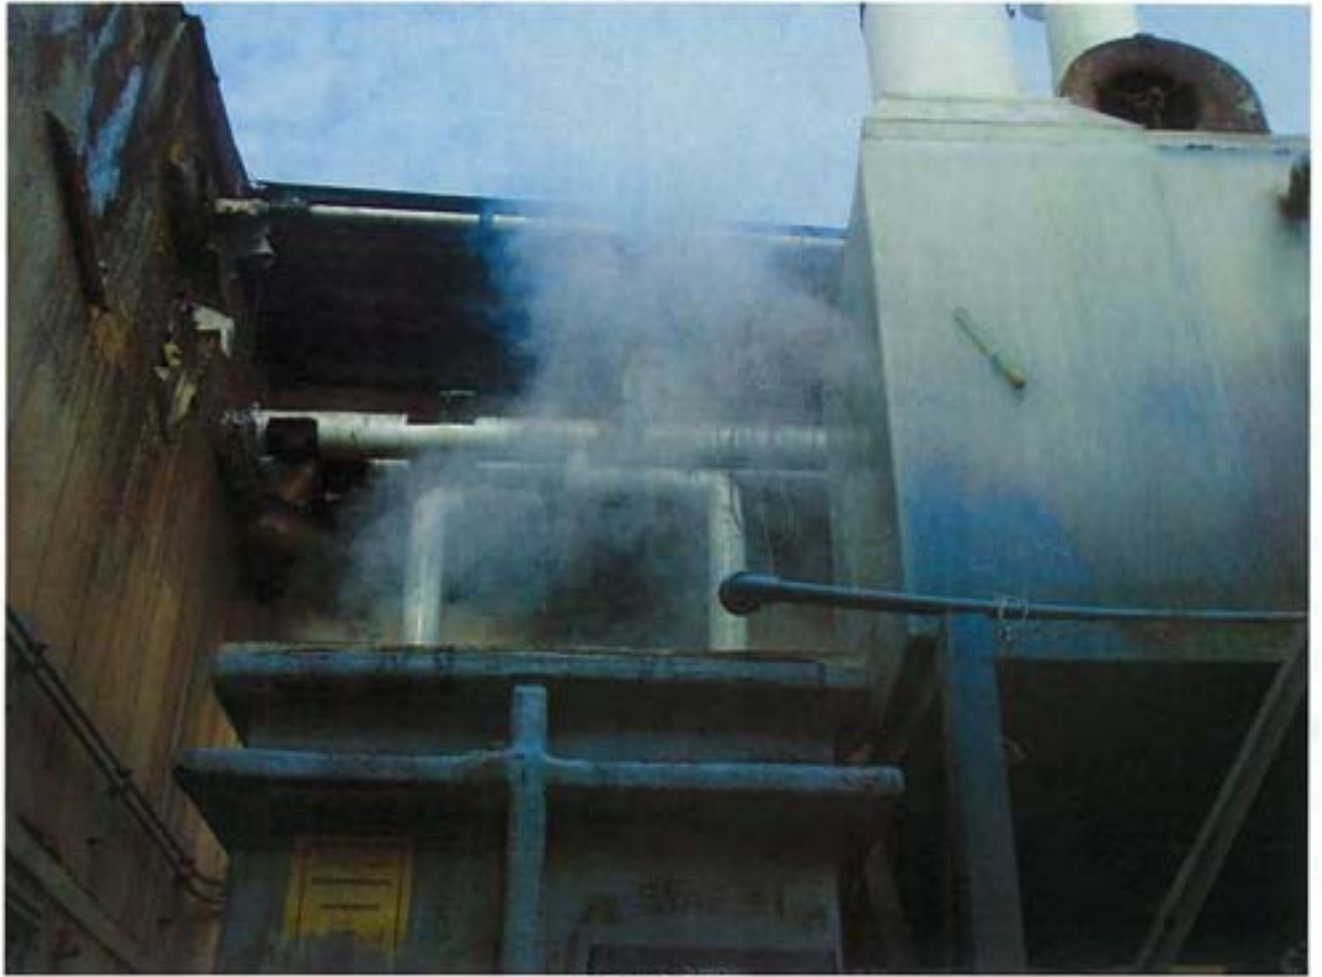
PC030050

- 049. Bulk Waste Processing Area: Open top containers of various sizes with liquid inside.
- 050. Bulk Waste Processing Area: View of evaporator and corroded walls and roof.

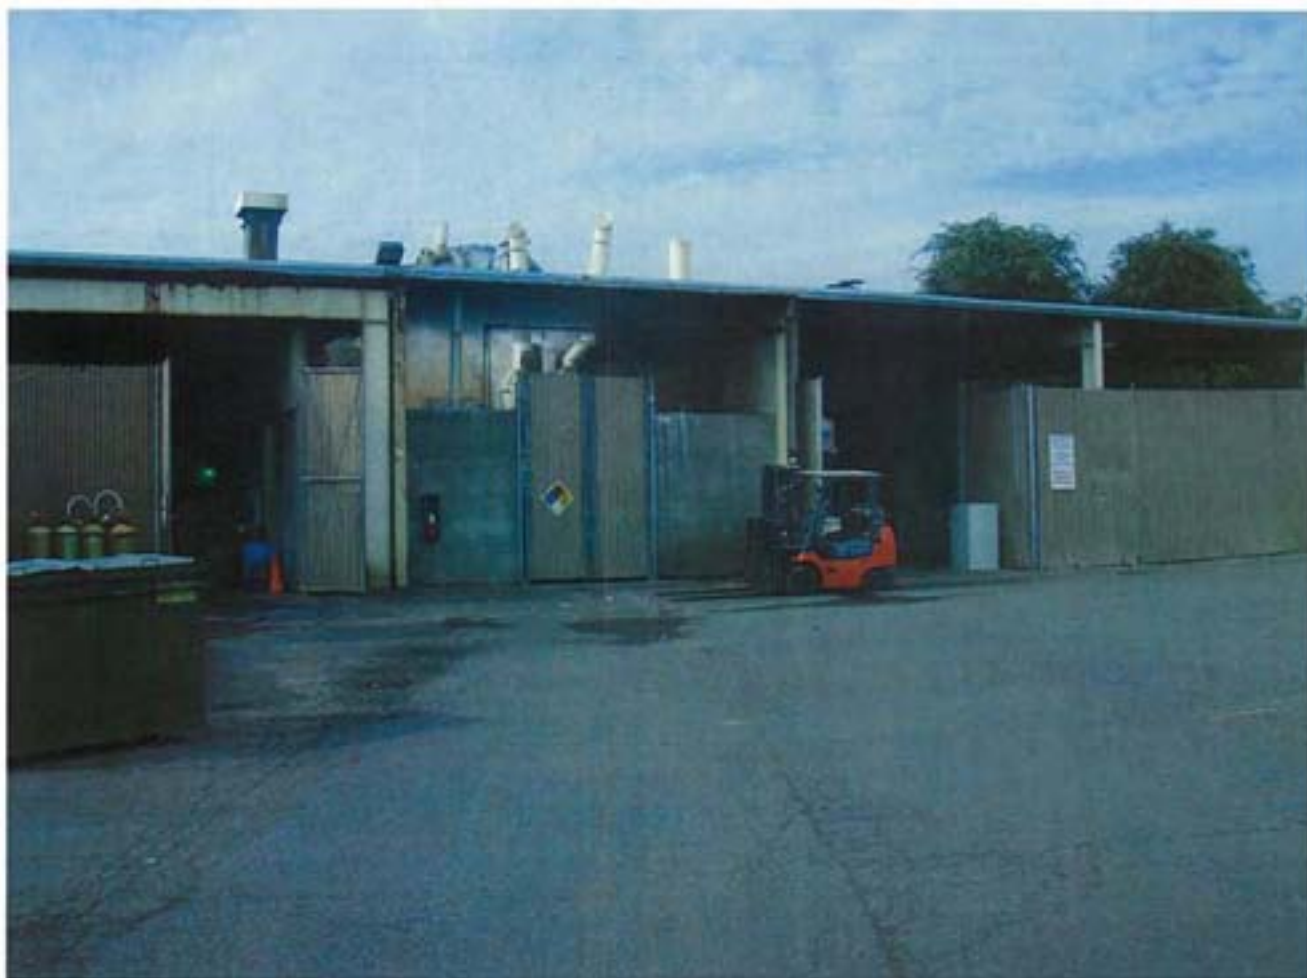
PC030060

- 060. Outdoor Area: View from the outdoor area the Water Treatment and Equipment Area, Bulk Waste Processing Area, and Maintenance Shop. Note puddle of liquid near forklift and Water Treatment and Equipment Area.
